HERITAGE SITE REVIEW

SQUAMISH UNITED CHURCH

NOVEMBER 2010
REVISED JANUARY 2011

DONALD LUXTON

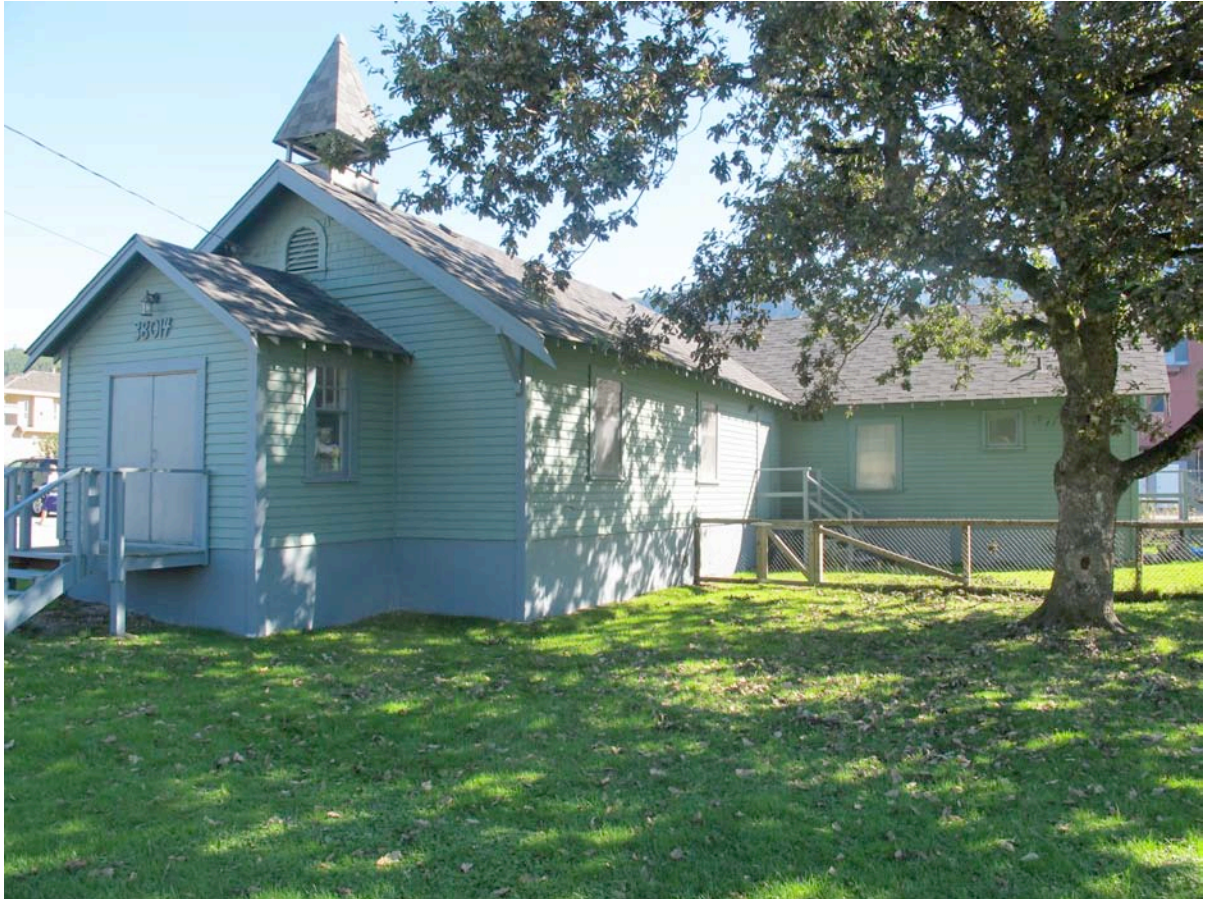
The original United Church building and its rear addition

The original United Church building has generally been well maintained, though it has been altered since its original construction in 1921. Typical of the remote and industrial nature of the early development of the community, the original portion of the church is a very modest structure with little elaboration. The Church was originally designed as a simple rectangular structure, approximately 20 feet wide by 30 feet long. The roof is a shallow-pitched front gable, with a small, attached front gabled porch/vestibule. In 1951, an addition was constructed to the rear of the building for use as a hall, kitchen and washrooms, extending to the east and south and more than doubling the size of the original. The original front entry is now closed off and used for storage, and the entrance to the building is now on the north side, accessed from the parking lot.

- Form and roofline
- Wood frame structure and construction, including wooden lapped siding, cornerboards, pointed bargeboards, triangular eave brackets, exposed rafter tails, cedar shingles and louvre in the gable end, and rooftop steeple

- Double-hung wooden-sash windows, 6/1 configuration on each side of the front vestibule and 8/1 configuration, two on each side in the original sanctuary
- Some interior features such as 5-panelled wooden doors and a fir floor

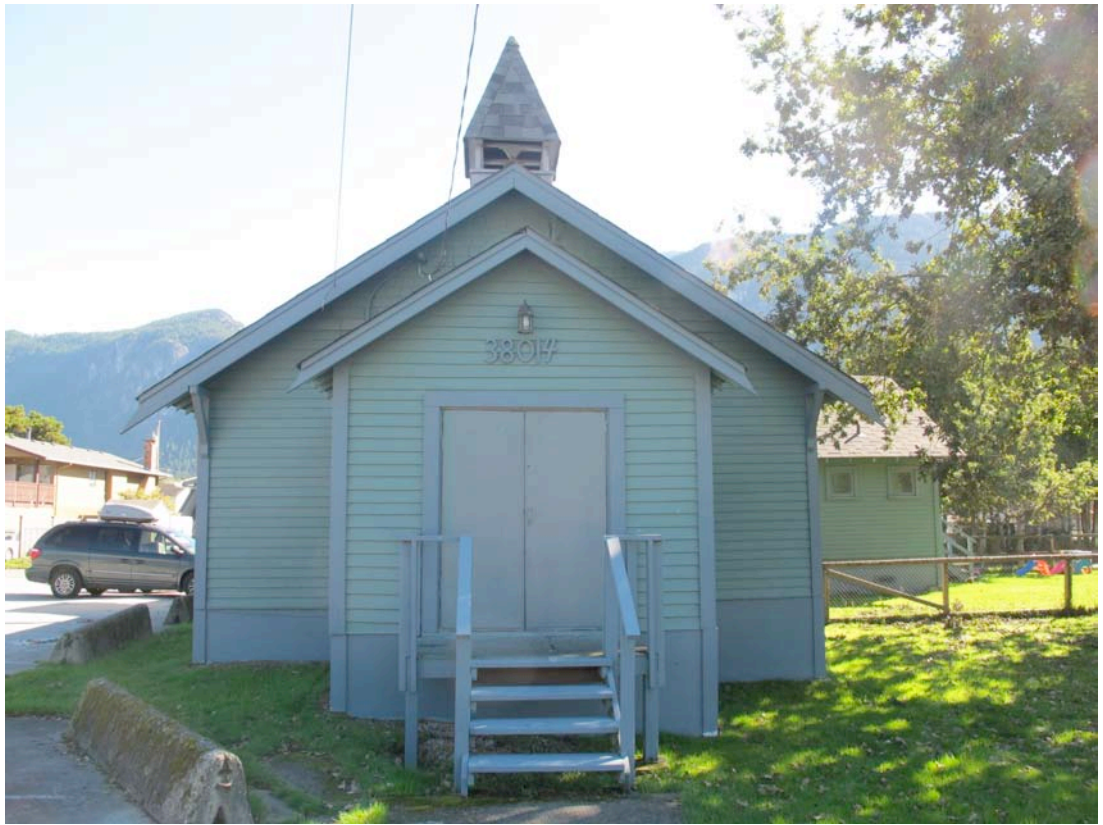
The original entrance to the United Church building

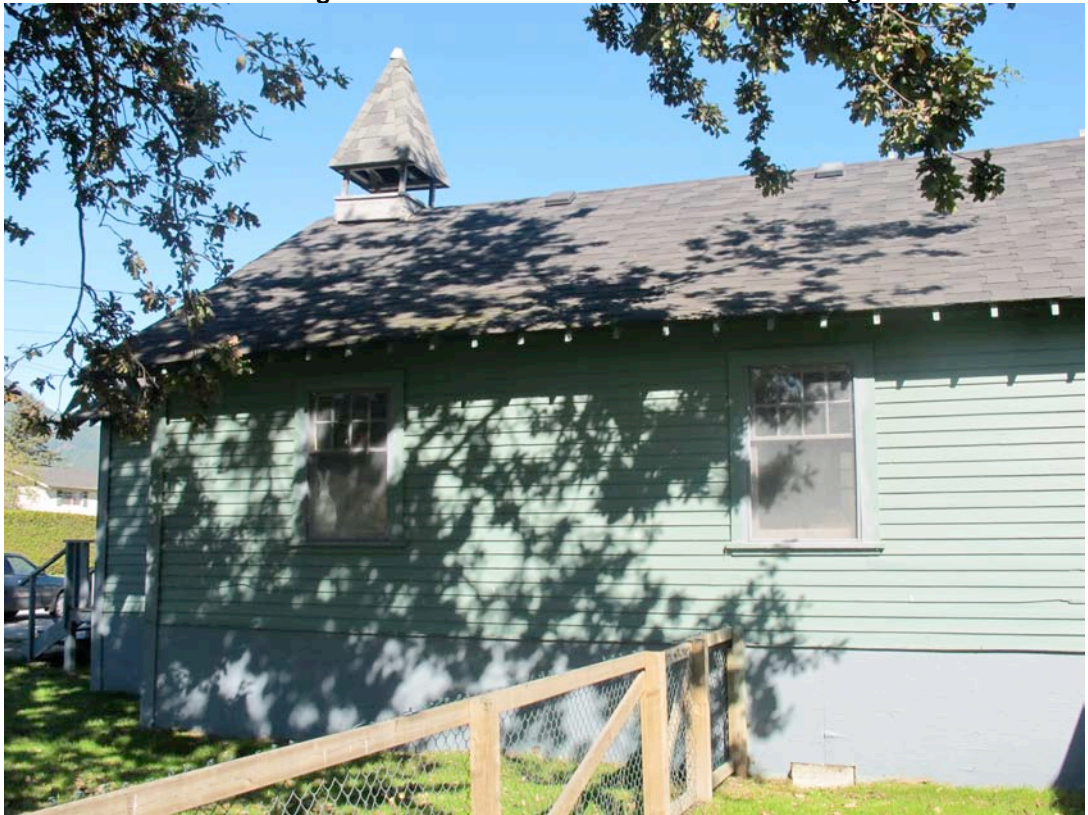
The south façade of the original United Church building

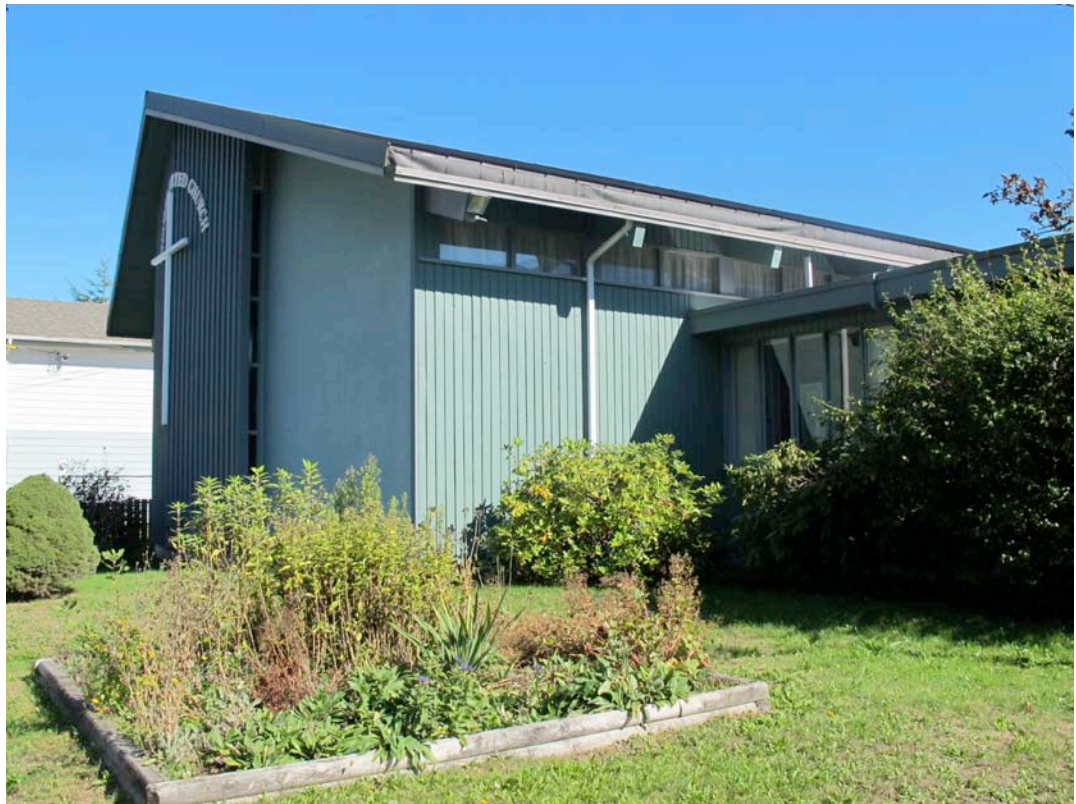
The 1963 Christian Education Centre Building

With the growth of the community, a new Christian Education Centre was built in 1963. The building was designed by Baxter & Whitley Architects & Town Planners of Vancouver. The Centre is a good example of modern, mid-century church architecture that reflects the West Coast style. Upon the completion of the new Centre, the original church building became known as the Annex. Retention of the 1963 building, which is in good condition, and has its own heritage merit and architectural significance, helps preserve the memory of the church function that has been characteristic of the site since 1921.
